Renovation of an office building with prefabricated wooden element - Case Hedensbyn

Karin Sandberg¹^[0000-0002-0006-9425], Anders Gustafsson¹, Anna Pousette¹^[0000-0003-0757-1909],
Joakim Norén² and Mohsen Soleimani-Mohseni³

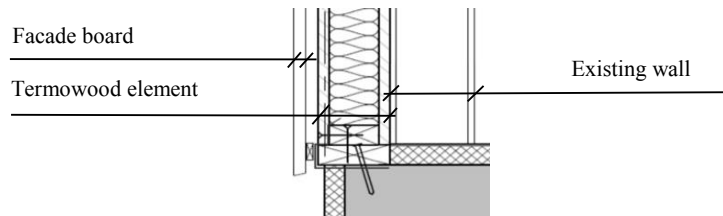
The facade was built with a ventilated air gap behind cladding, and façade boards were fixed to double battening of horizontal 28- x 70-mm and vertical 12- x 48-mm battens. For a cross-section of the lower bottom part of the wall, see Fig. 3.

Fig. 3. Wall section of renovation with Termowood elements and facade boards.

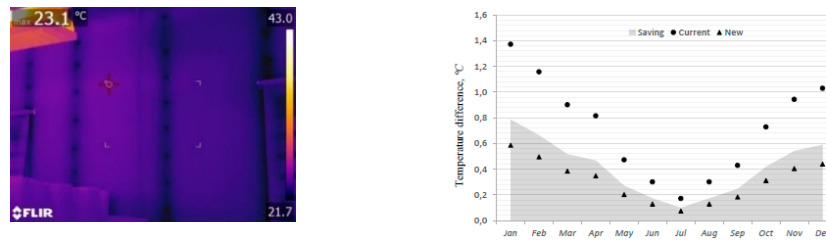
The major thermal bridges are usually located at connections. In this case, it was important to study the surface thermal bridges caused by the timber frame and assess how much energy could be saved by reducing these thermal bridges. Thermographic pictures taken before the renovation are shown in Fig. 5.

Simulation results of thermal bridges showed that the temperature difference between points on the inside of the wall at the position of studs and positions between studs (no thermal bridge) was reduced with added insulation (see Fig. 5). In January (coldest winter month), the reduction was from 1.4°C to 0.6°C, and in July (warmest summer month) the reduction was only from 0.2°C to 0.1°C. The average for the year after refurbishment was 0.41°C. From this, the energy losses were calculated, and the calculated energy saving on average was 3.5 kWh/m² of wall surface in a year as a result of reduced thermal bridges at the studs.

Fig. 5. Thermographic pictures show cold spots along the timber frame (studs). To the right, temperature difference calculated.
