Influence of the Thermal Environment of a Bathroom after Renovation on Blood Pressure of Residents

Abstract.

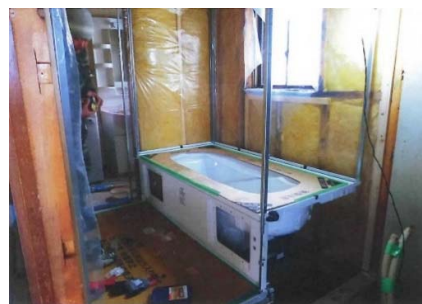
Figure 4. Setting of new bathtub

- (2) **House B.** The tiled bathtub was replaced with a bath module with thermal insulation to prevent a drop in temperature of the hot water (Figures 3 and 4). The tiled bathroom was also insulated to increase the bathroom temperature (Figures 3 and 4). The service door leading to the corridor adjacent to the dressing room was also insulated.

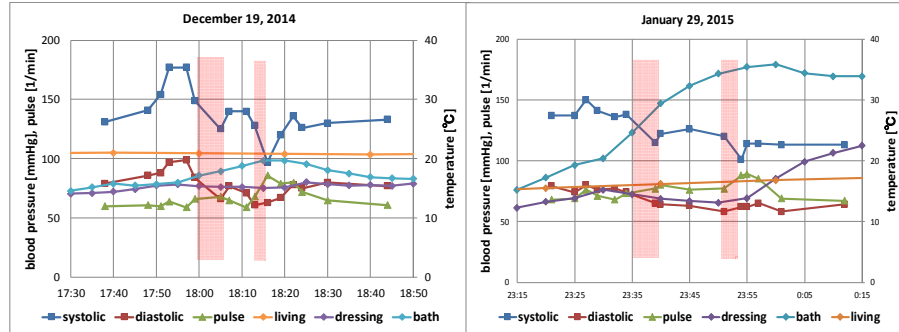
Figure 9. Systolic and diastolic blood pressure of House B husband (left: before renovation; right: after renovation)

Figures 9 and 10 show the systolic and diastolic blood pressure of the husband and wife in House B during bathing, respectively, along with the temperatures of the living room, dressing room, and bathroom. The set point of the hot water temperature was between 40°C and 42°C, and neither the husband nor the wife reheated the hot water.

Husband (Figure 9). Before renovation (December 19, 2014), the systolic blood pressure of the husband increased from 130 to 180 mmHg in the dressing room and decreased to 100 mmHg in the bathtub. But after the renovation (January 29, 2015), it increased only up to 150 mmHg in the dressing room. Through the whole bathing process, systolic blood pressure decreased from 80 to 50 mmHg. Before the renovation, the dressing room temperature before bathing was approximately 15°C whereas it was 16°C after bathing, and these values increased to 16°C and approximately 18°C, respectively, after the renovation.

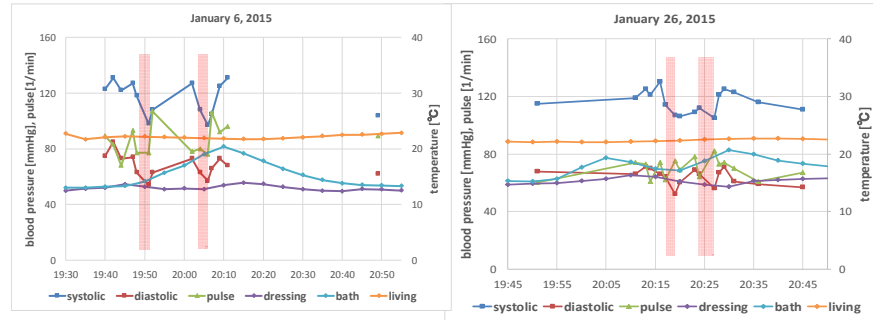
Figure 12. Systolic and diastolic blood pressure of House C wife (left: before renovation; right: after renovation)

Wife (Figure 12). Before the renovation (January 6, 2015), the systolic blood pressure of the wife in House C was approximately 130 mmHg in the dressing room and decreased to 100 mmHg in the bathtub. The total change in the systolic pressure was 30 mmHg. After the renovation (January 26, 2015), the total change in the systolic pressure slightly decreased to 25 mmHg, although the dressing room temperature became higher from 13°C to 15°C after the renovation.
